**EXHIBIT F TO JOINT NOTICE OF
COMPLETION OF CLEANUP, JOINT
NOTICE OF SETTLEMENT AND
[PROPOSED] ORDER TO VACATE
DATES AND DEADLINES**

INITIAL SAMPLING AND ANALYTICAL PLAN (SAP)

QUANTUM LABS DECONTAMINATION PROJECT

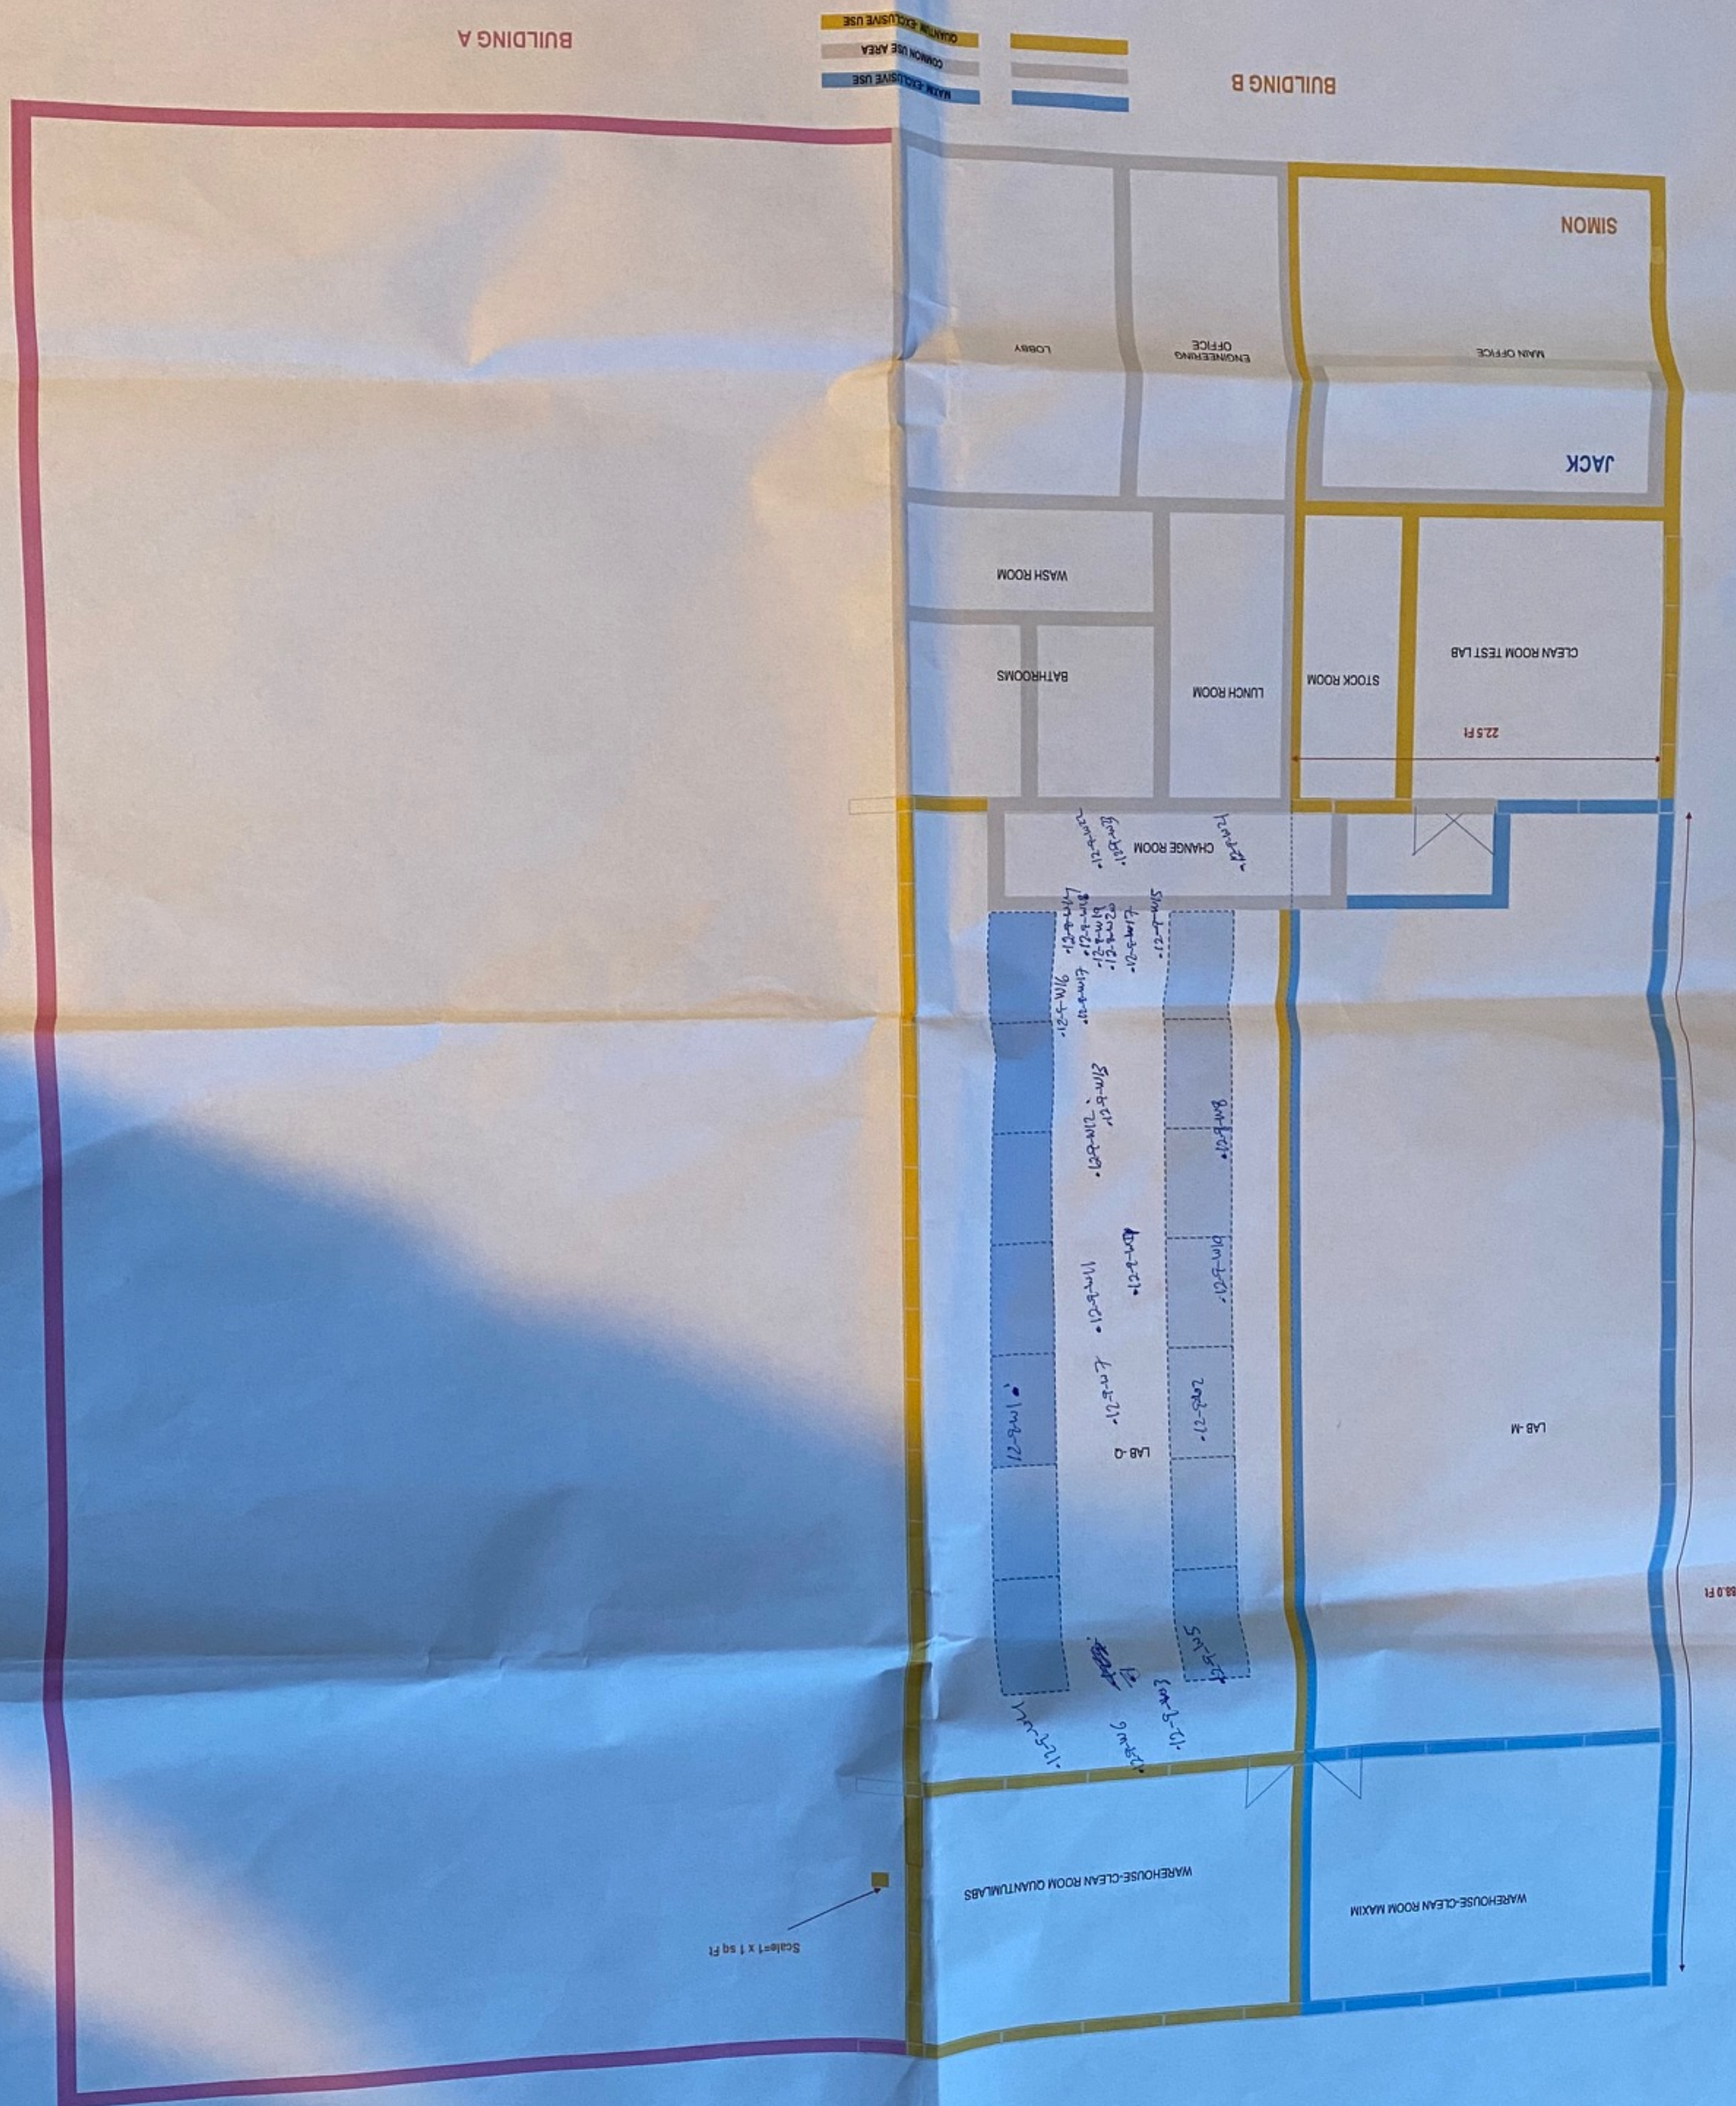
FIGURE 1 -FLOOR PLAN WITH WIPE SAMPLING LOCATIONS

- This dust evaluation did indicate cobalt dust contamination inside the Temescal Exhaust Fan located on the roof of this building, with surface contamination levels extremely elevated for this sample. Therefore, based on the extremely elevated cobalt 59 concentration in the Temescal Exhaust Fan, the following HVAC components are considered potentially contaminated and should be decontaminated by Belfor Environmental:
- Motionless air areas where dust accumulates
- Area at the top of air ducts
- Access flanges

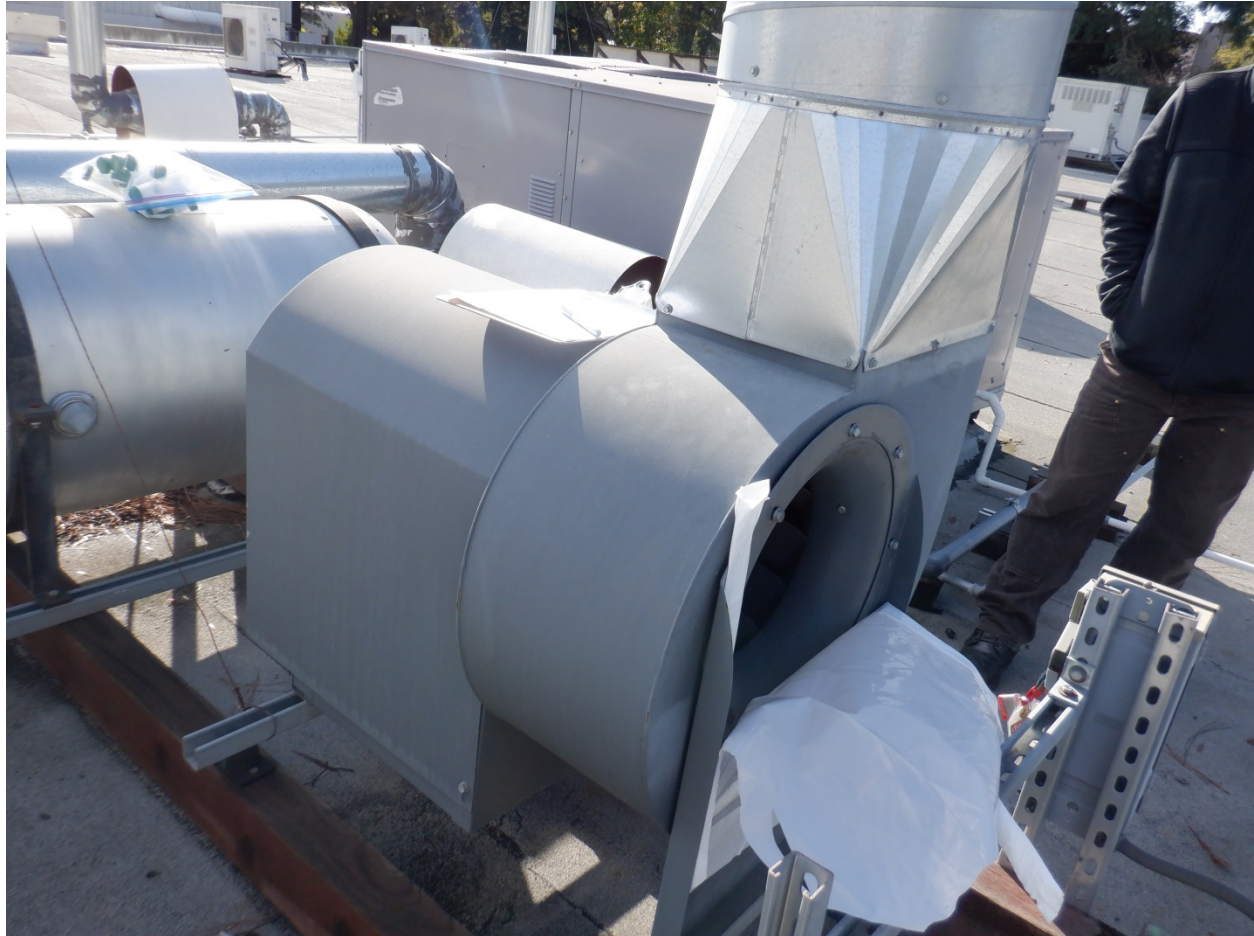
Photo 33-Temescal exhaust fan

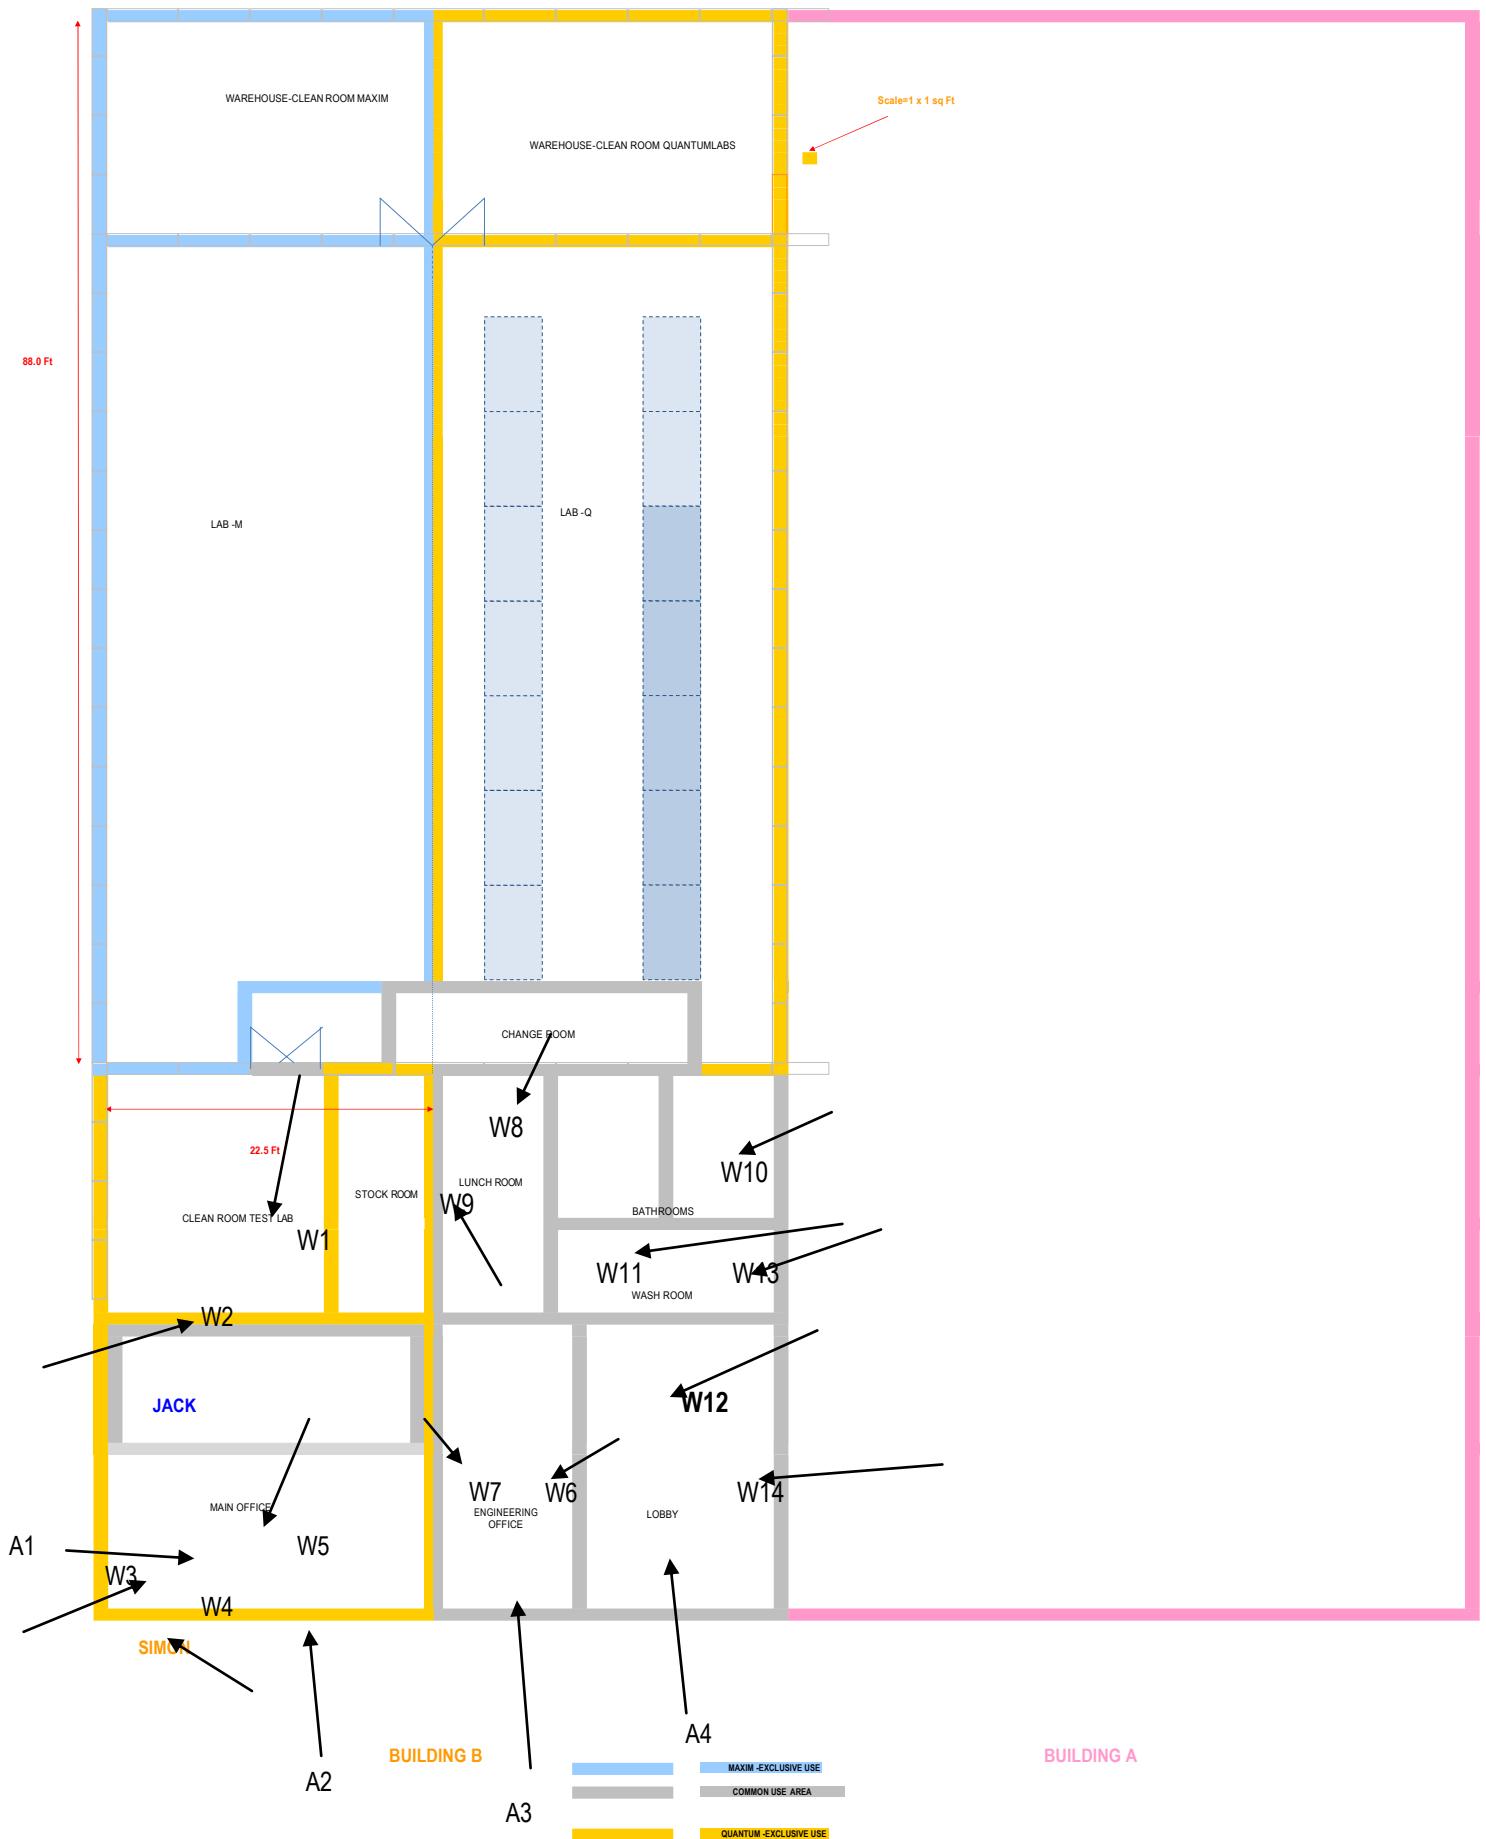
FIGURE 1 -FLOOR PLAN WITH WIPE SAMPLING LOCATIONS

However, this dust evaluation did indicate cobalt dust contamination of the carpet in Simon Planck's office. Therefore, all carpeted office areas should have the carpet removed and discarded as hazardous waste as this material is extremely porous and is a potential source of cobalt contamination.
